STS-51 PAD ABORT

8-12-93

OV103 - ENGINE 2033 (ME-2)  
FUEL FLOWMETER  
SENSOR OPEN CIRCUIT

STS-51 PAD ABORT  
FINAL REPORT

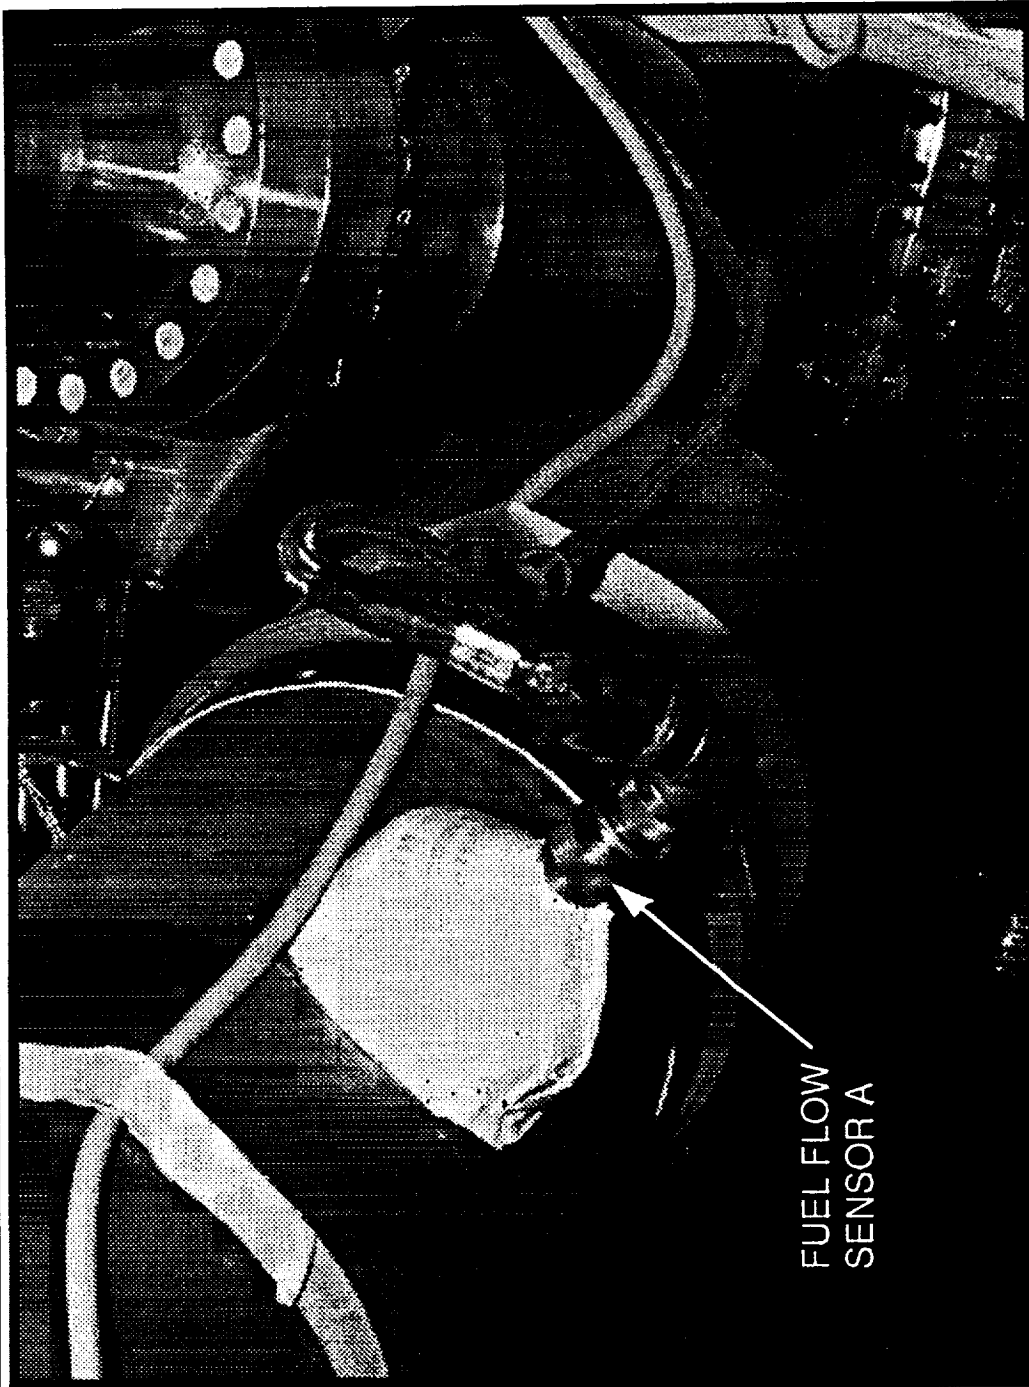
During testing at Rosemount the wire in the A2 side of the sensor was verified to make contact at ambient conditions but would be open when chilled. This is consistent with the failure (Figure 7). The final analysis identified that potting compound cracks were the reason for the failure which can be considered a design deficiency. Workmanship problems were also identified which could have contributed to the early failure. This will be documented in Rocketdyne UCR/FAR A032605 and Rosemount disassemble report D9330225.

# STS-51 PAD ABORT ME-2 (ENGINE 2033) FUEL FLOW SENSOR

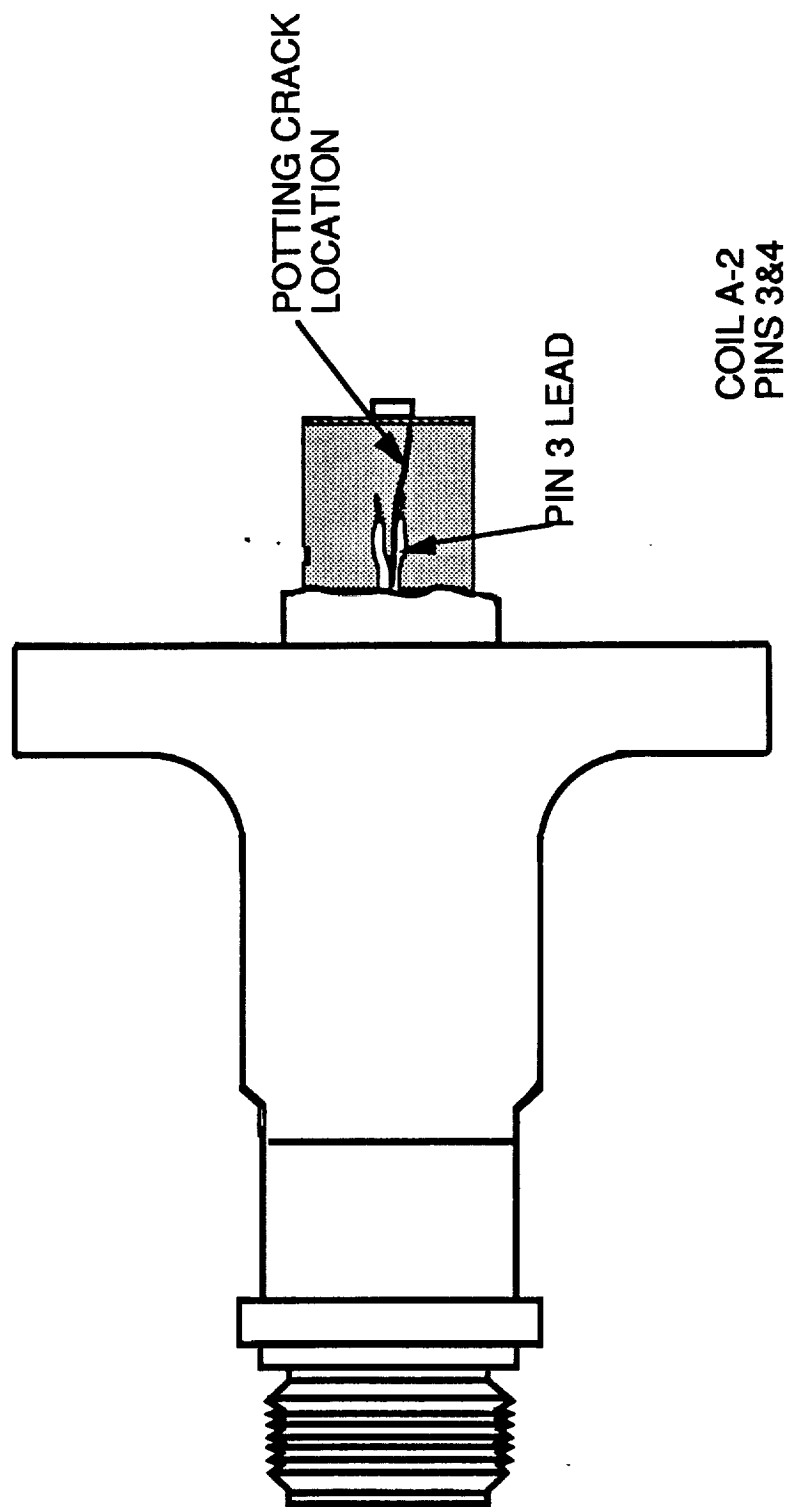
FIGURE 2

over the coil area was machined partially through its thickness. Finally, the remaining stainless sheath membrane was carefully peeled away revealing the potted coil pickup assembly. A single axial crack was observed in the potting and continuity checks from the electrical connector confirmed that the crack was over the Pin # 3 lead. The appearance of the coil is illustrated in Fig. 2.

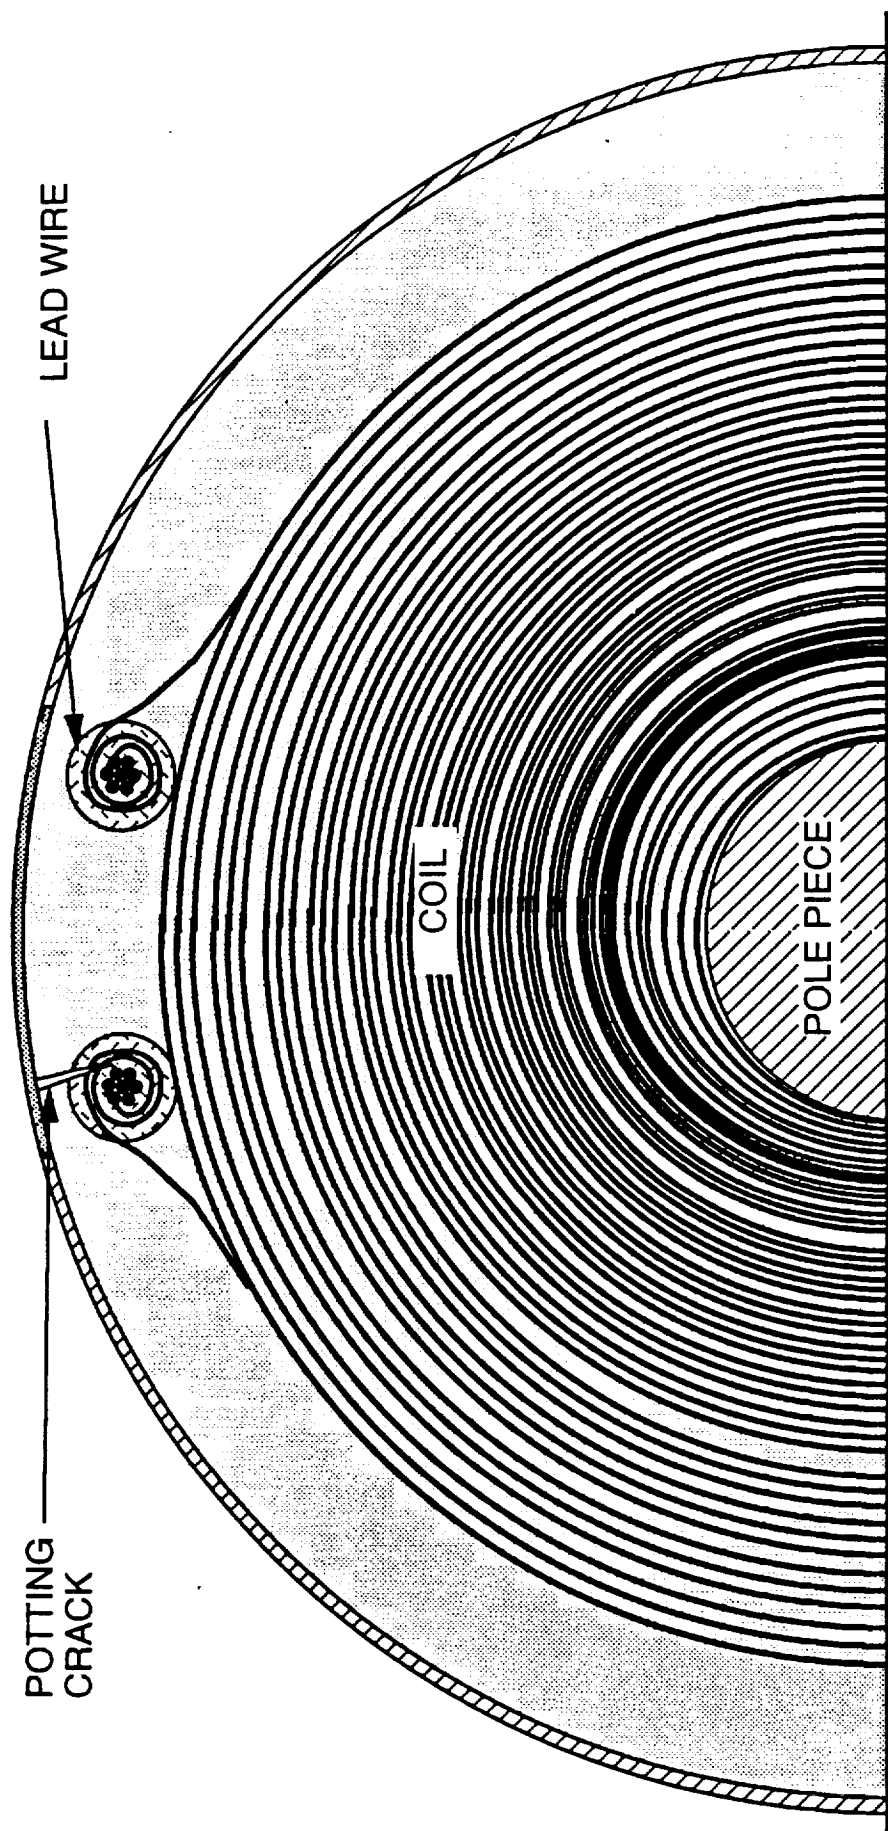
FIGURE 3

Evaluation of the source of the open condition required that the Hysol PC12-007 potting material be removed in a manner so as to minimize manipulation of the coils and lead wires. Mechanical methods were discounted. A solution of Eccostrip and water was utilized to soften and dissolve the epoxy. Examination of the part after ~2 hours in the solution revealed a suspected break in the coil wire. The part was allowed to remain in the solution overnight. Visual examination resumed on 18 August. Continuity checks through the remainder of the coil verified that the coil itself was intact. Microscopic examination disclosed that the break was located ~375° from braze joint to 32 AWG lead wire (15° into second strain relief turn).

# STS-51 FUEL FLOW SENSOR LOCATION OF FAILURE

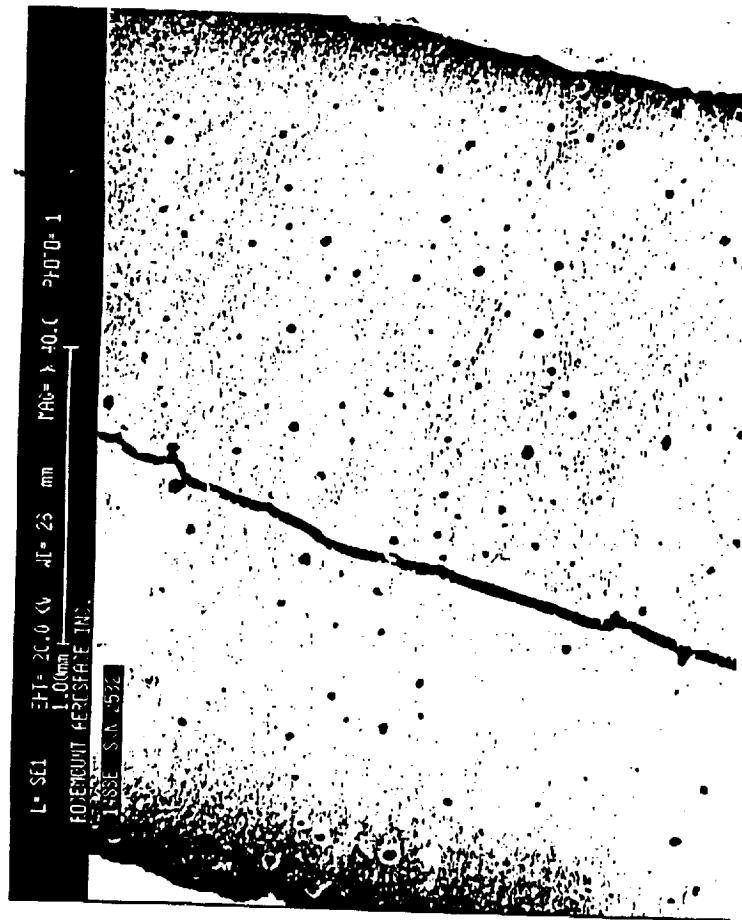
FIGURE 1

SEM Microphotograph  
of coil potting surface.  
Crack path connects  
voids (40X).

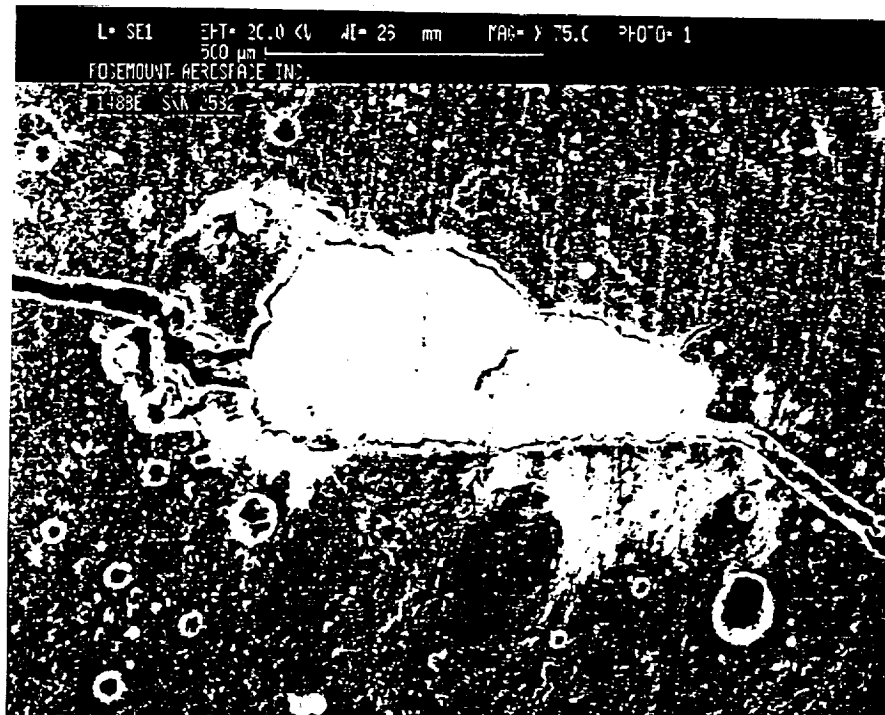
The epoxy crack was examined in the SEM and estimated to have a maximum width of 0.002". Although primarily axial, the crack diverted slightly in direction to connect surface imperfections in the epoxy. Neither the braze joint lead wire nor coil wire were visible while viewing down into the interior of the crack. Figure 3 supports the conclusion that the epoxy crack initiated around the perimeter of the island of exposed wire insulation.

RES7005-61 FLOW SENSOR, S/N 2582 SSME 2033  
EXPOSED INSULATION & EPOXY CRACK 75X  
FIGURE 3
